Appendix J
Grand Canal Photography Log

Photo Log of Grand Canal

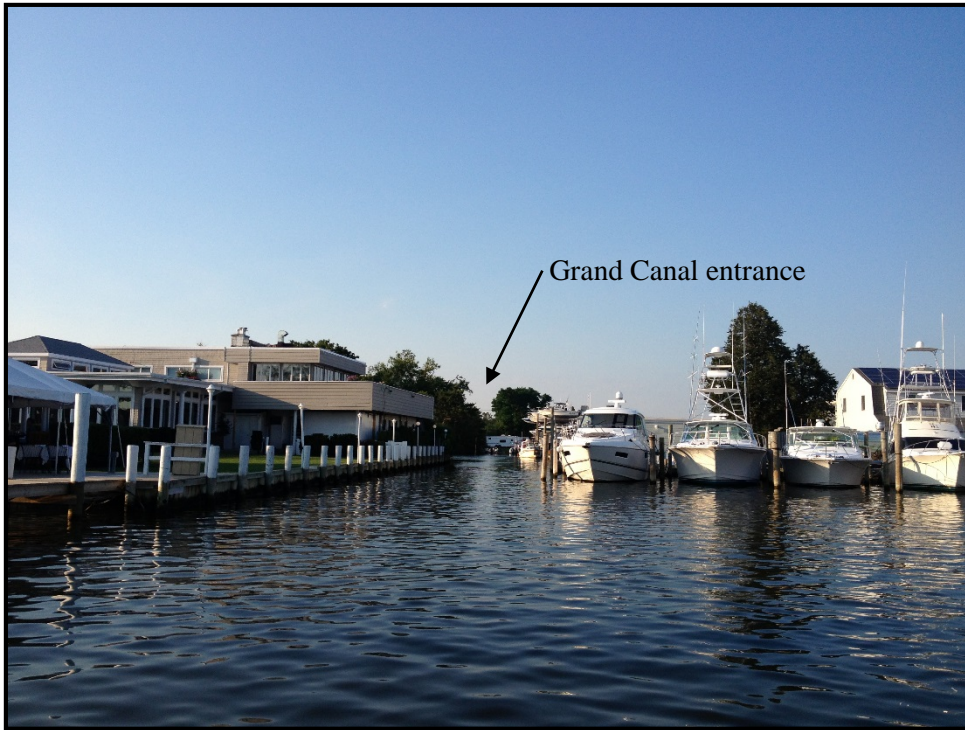
South entrance to Grand Canal is narrow, between restaurant and boatyard property, and restricts tidal exchange with canal.

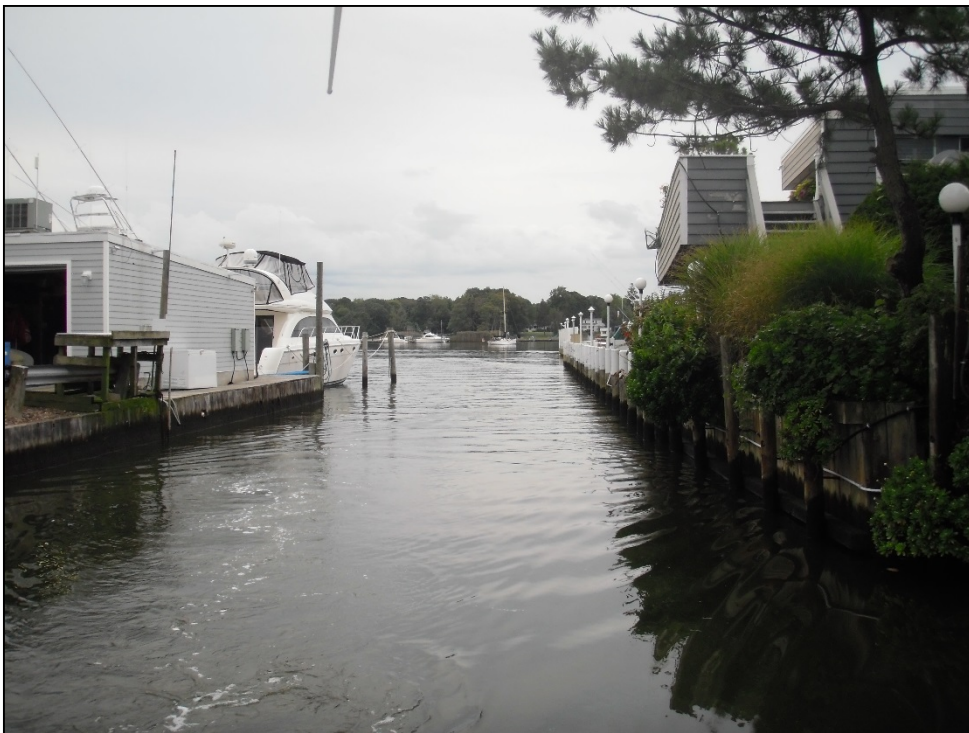
Narrow south entrance of the canal.

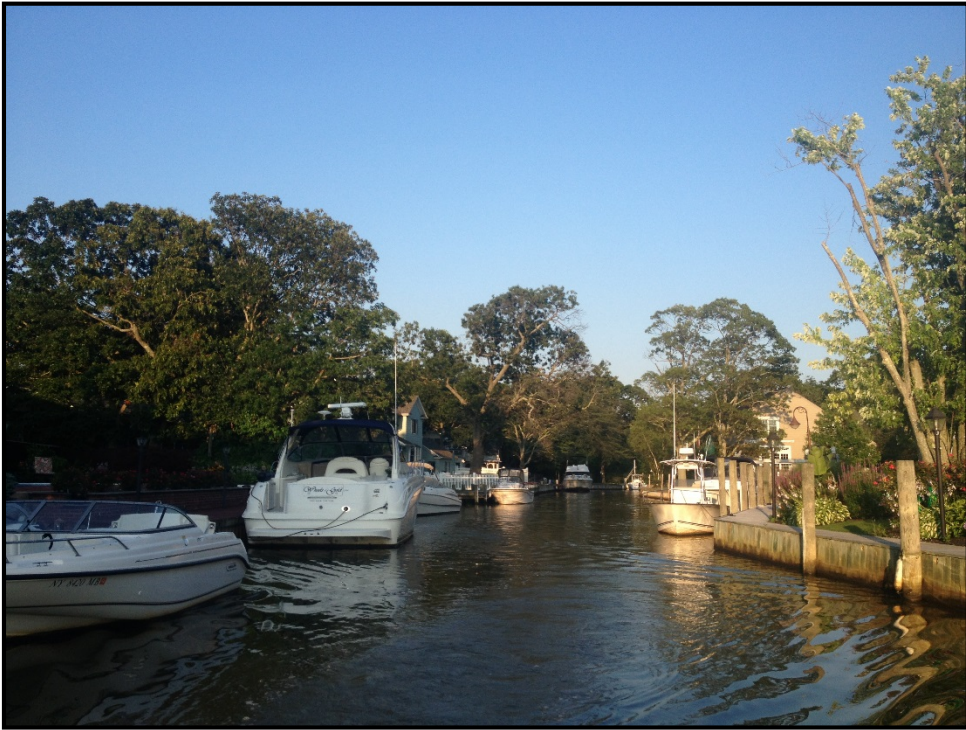
Much of canal is used for boat dockage along private properties.

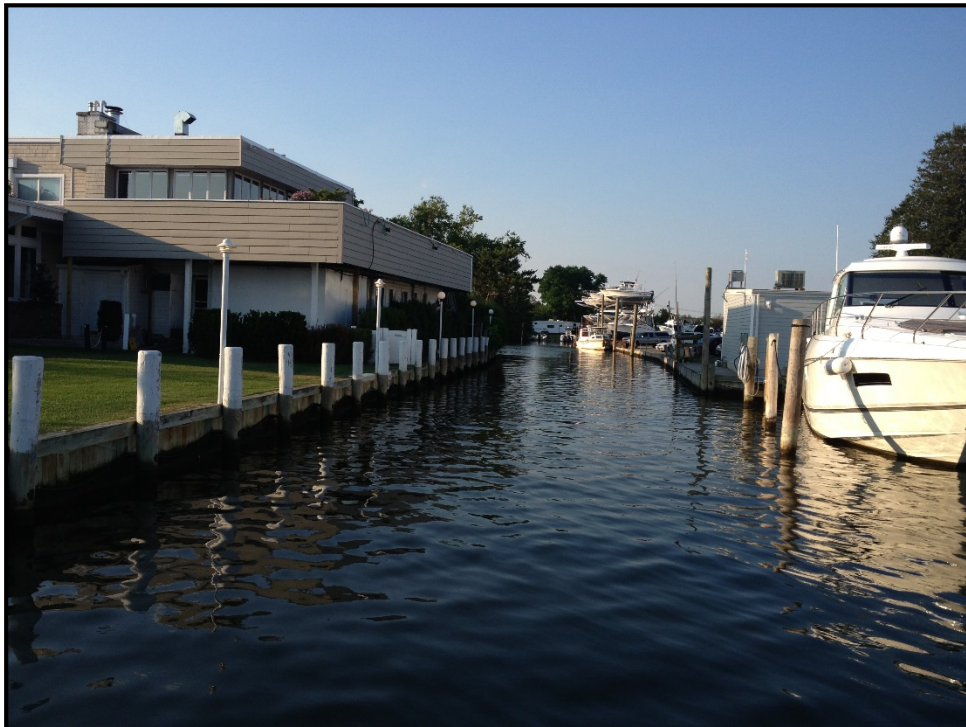
Buildings and homes are in close proximity to canal edge.

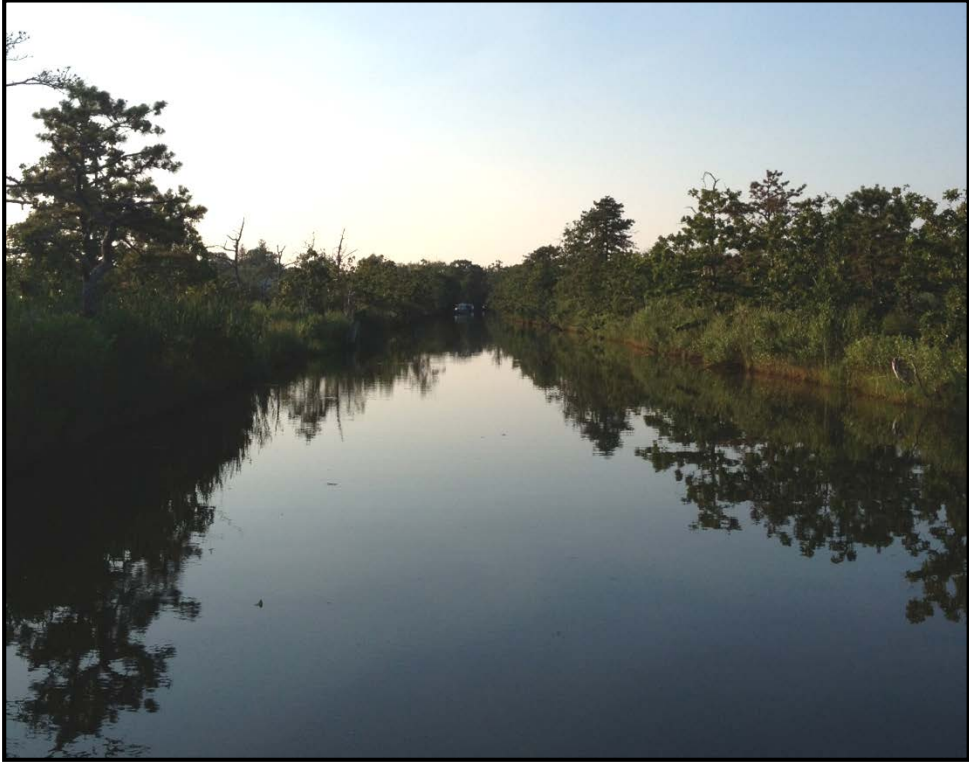
Portions of the canal shoreline are undeveloped

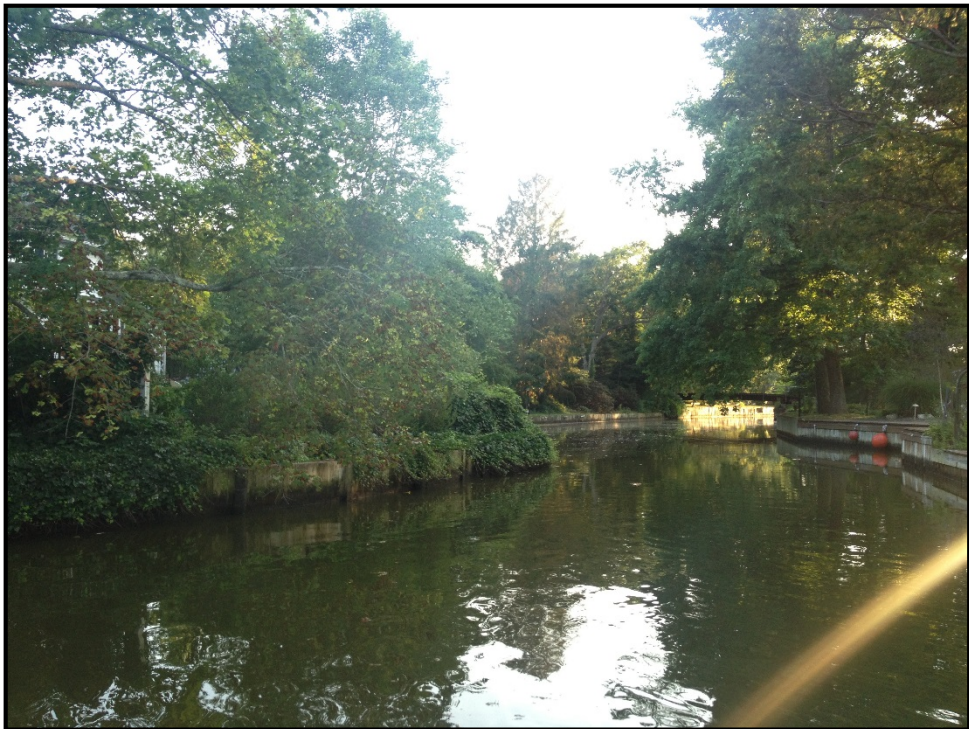
Much of the canal is characterized as visually pleasing, with historic aesthetic setting.

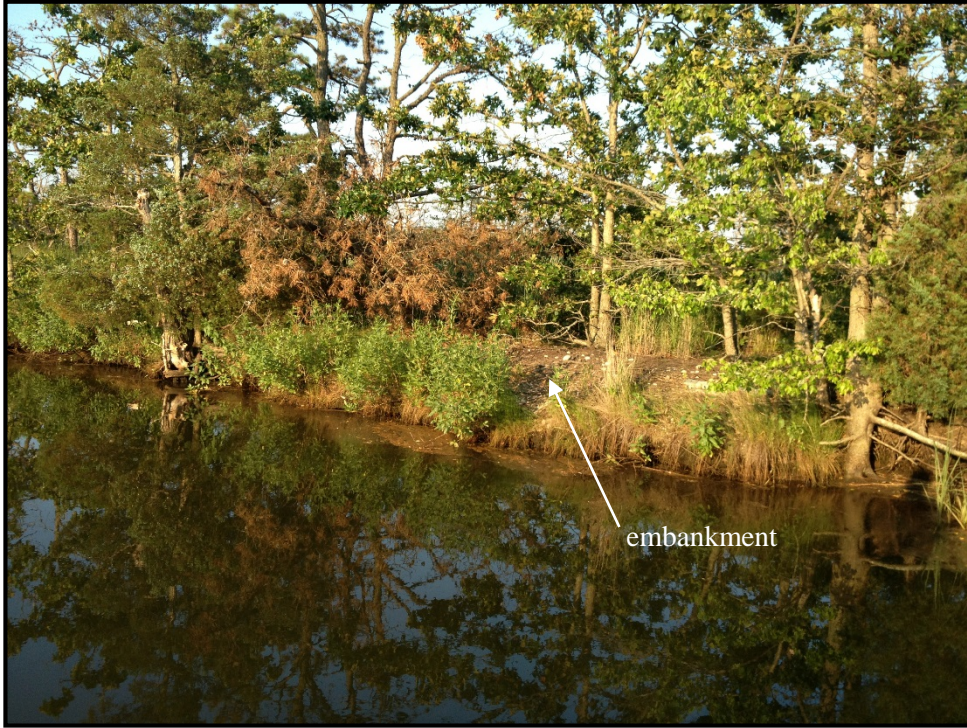
A man-made eastern embankment separates the canal from extensive wetland areas (Pickman-Remmer Wetland).

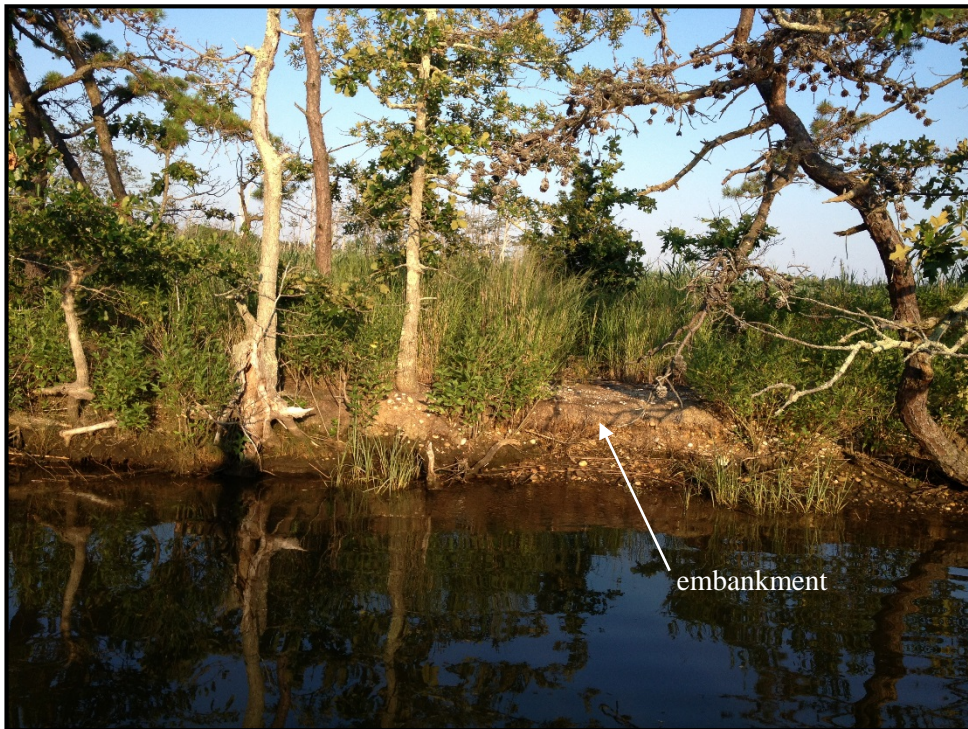
The embankment which separates the canal from the wetland areas is restricted with trees, many of which have exposed roots from erosion.

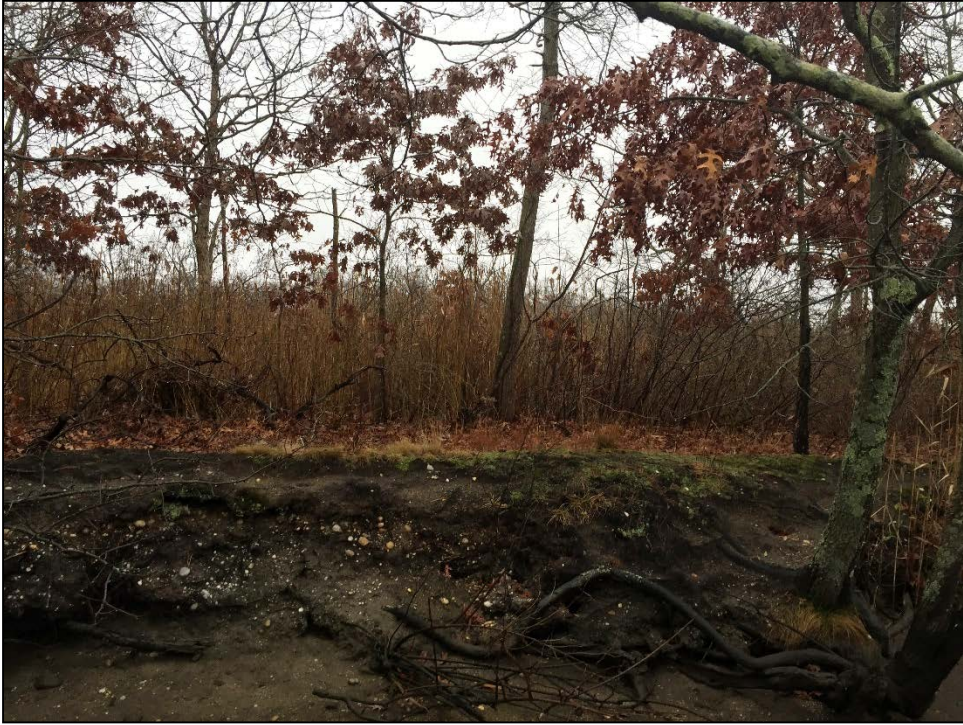
Areas of the berm show evidence of extensive erosion, representing a continuing source of sediment to the canal.

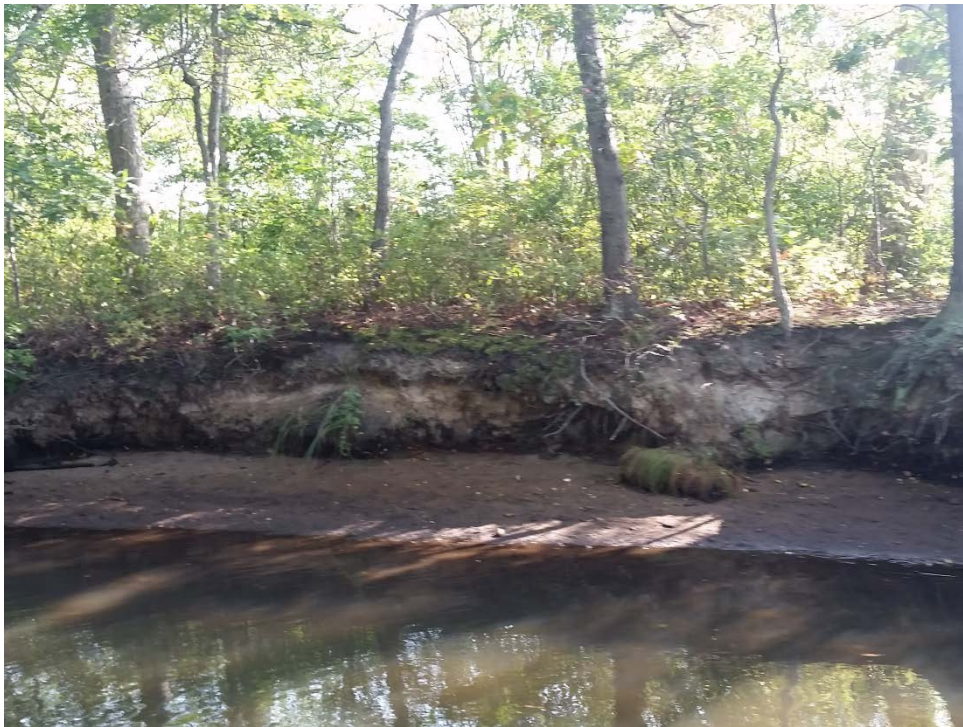
Additional areas of eroded berm.

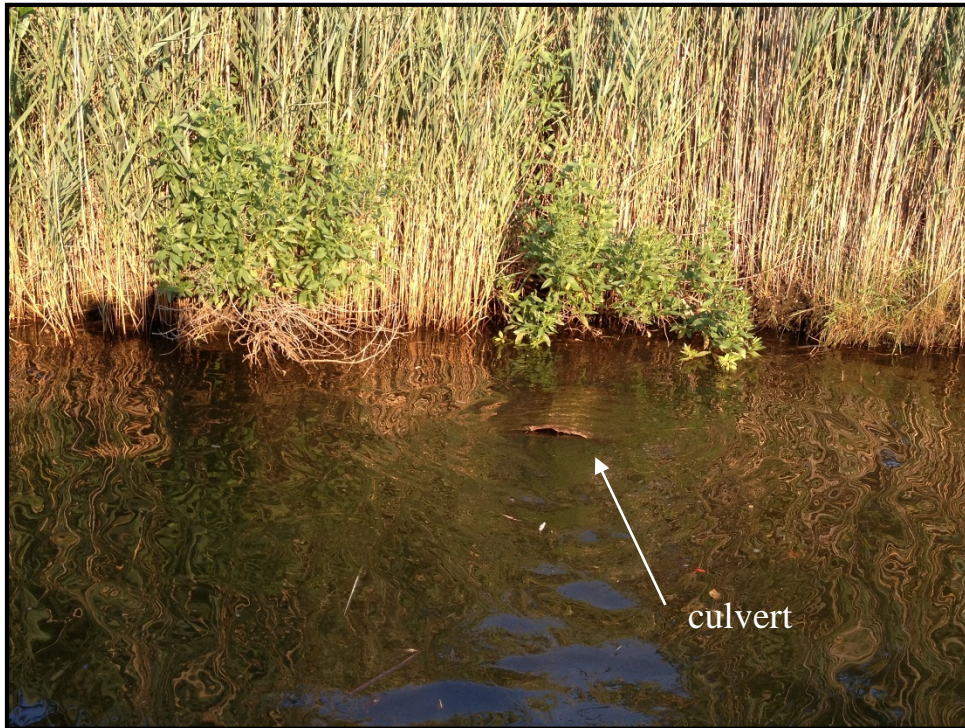
Deteriorated culverts provide limited connection from wetlands to canal, through embankment

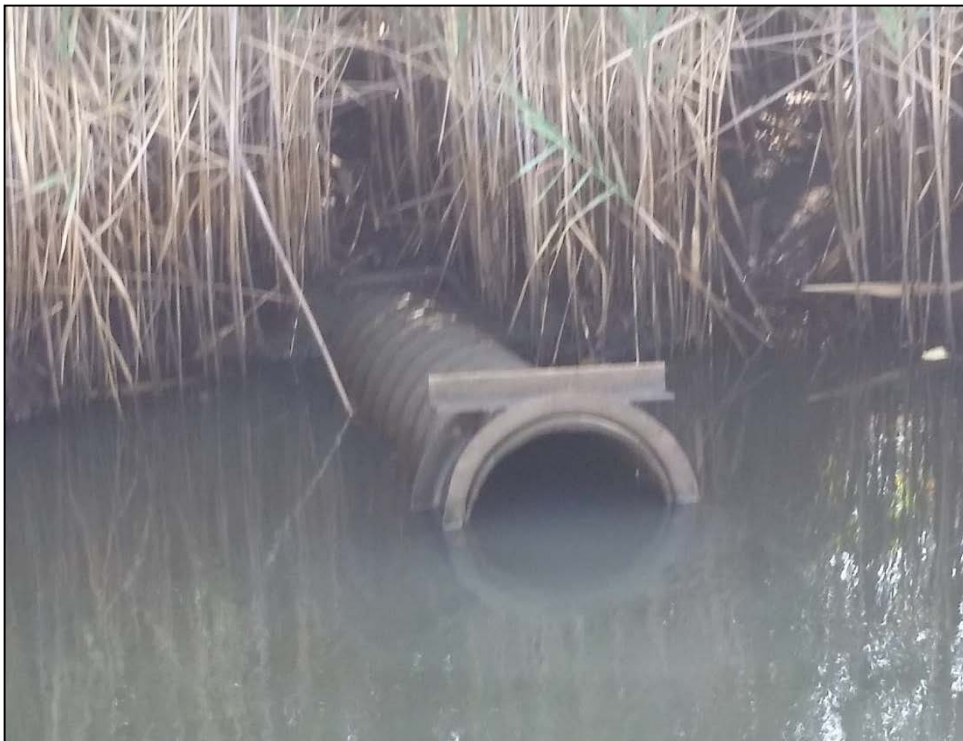
Culverts in poor condition provide little tidal exchange between canal and bermed wetlands.

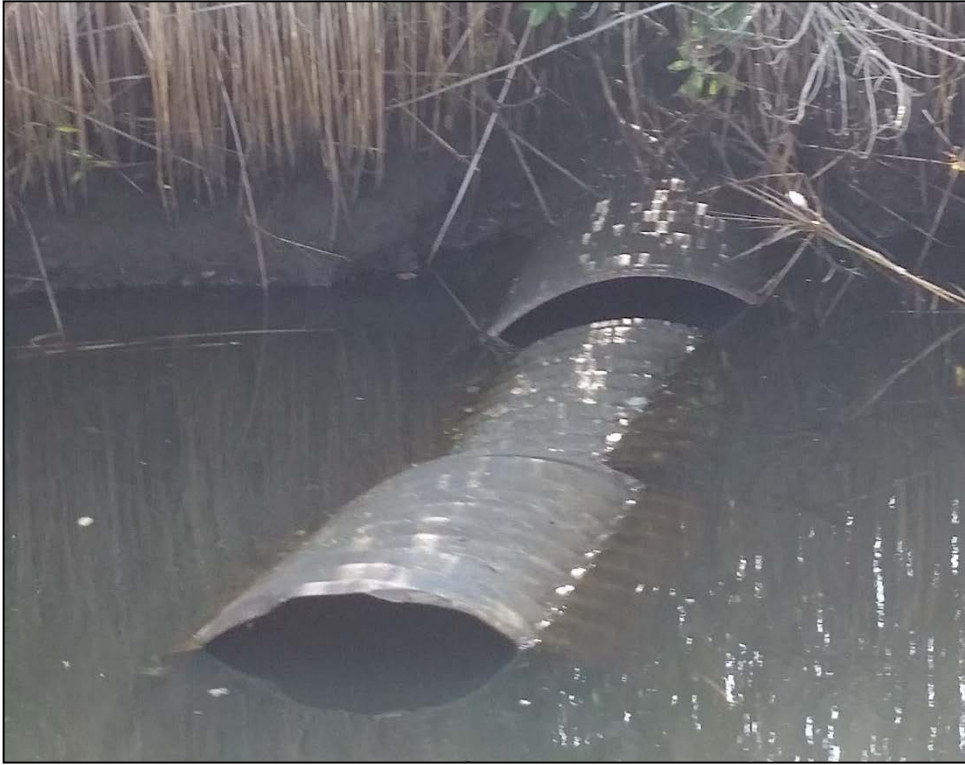
Culverts in poor condition provide little tidal exchange between canal and bermed wetlands.

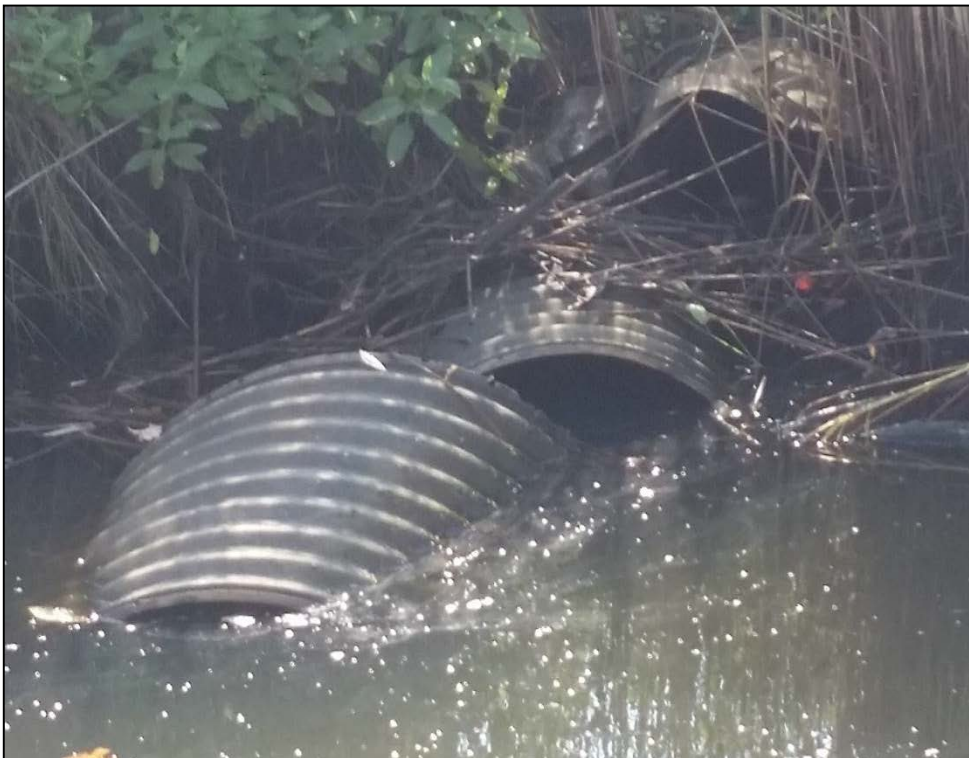
Culverts in poor condition provide little tidal exchange between canal and bermed wetlands.

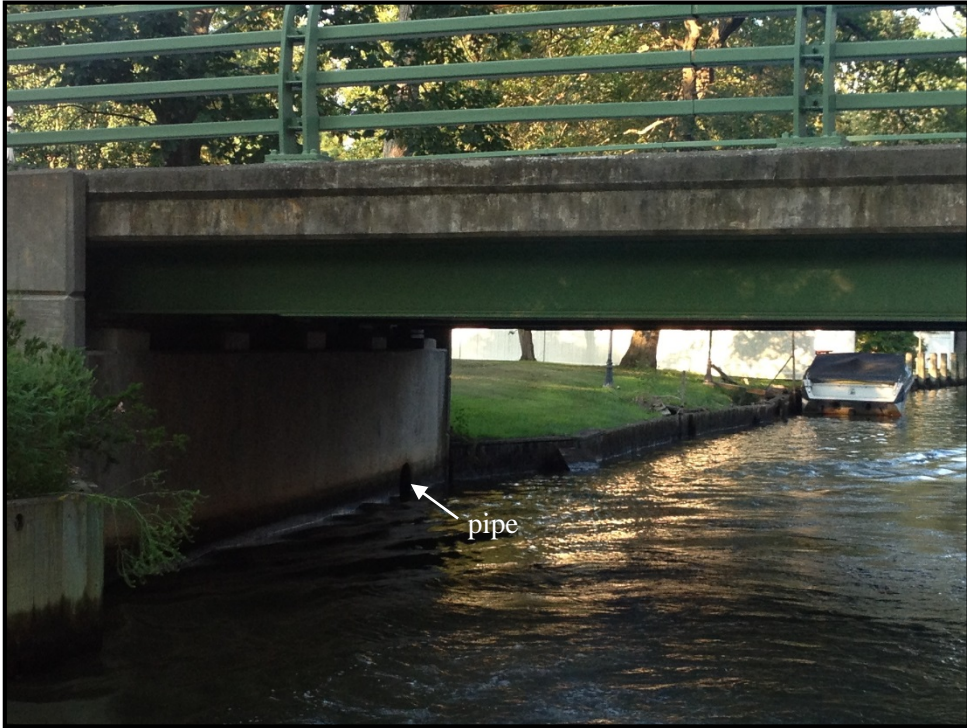
Stormwater outfall pipe from roadway is shown above

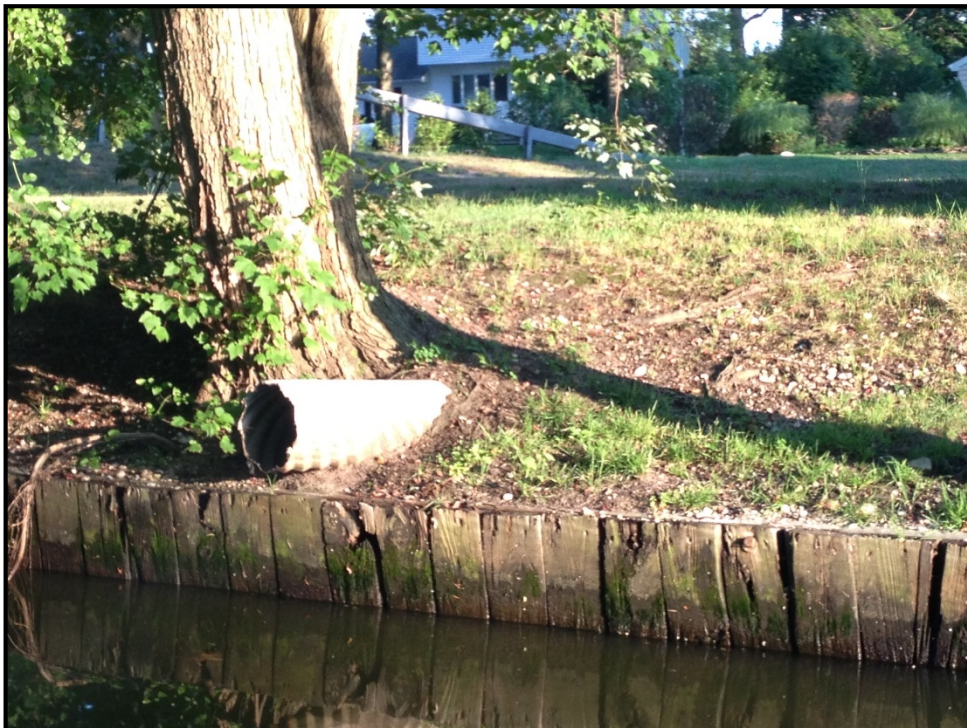
Stormwater discharge pipes of various sizes are located along canal.

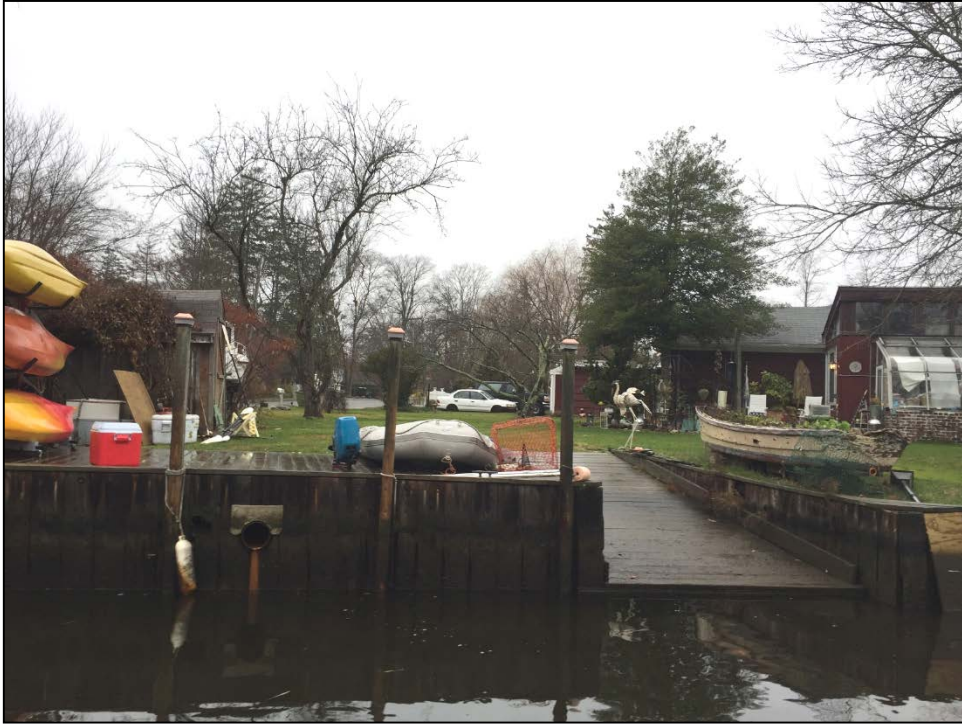
Stormwater outfall discharge to the canal.

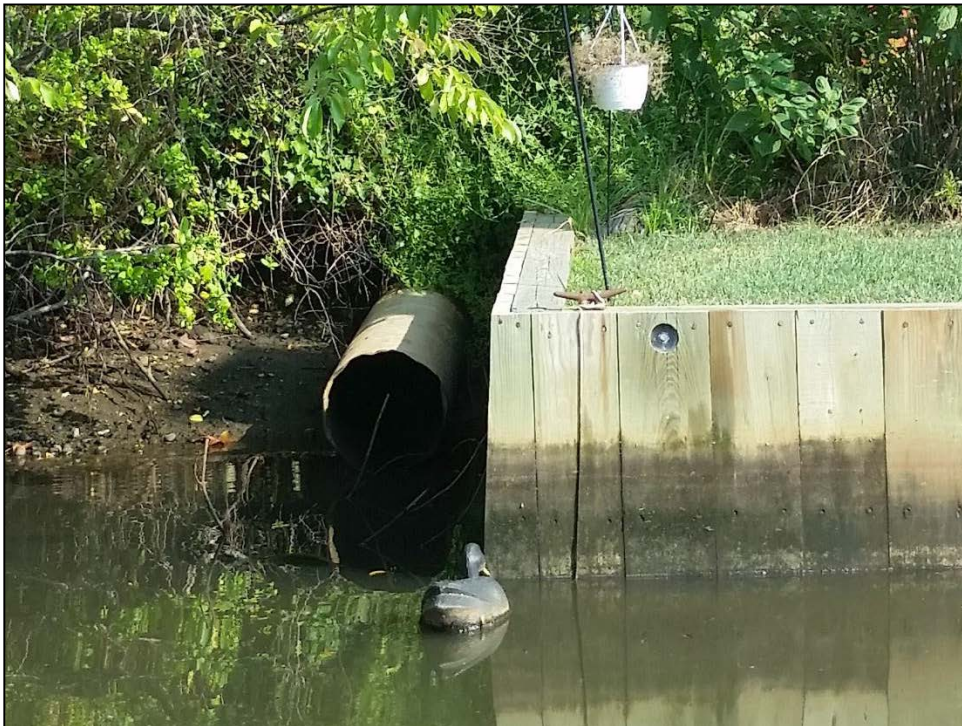
Stormwater outfall discharge to the canal.

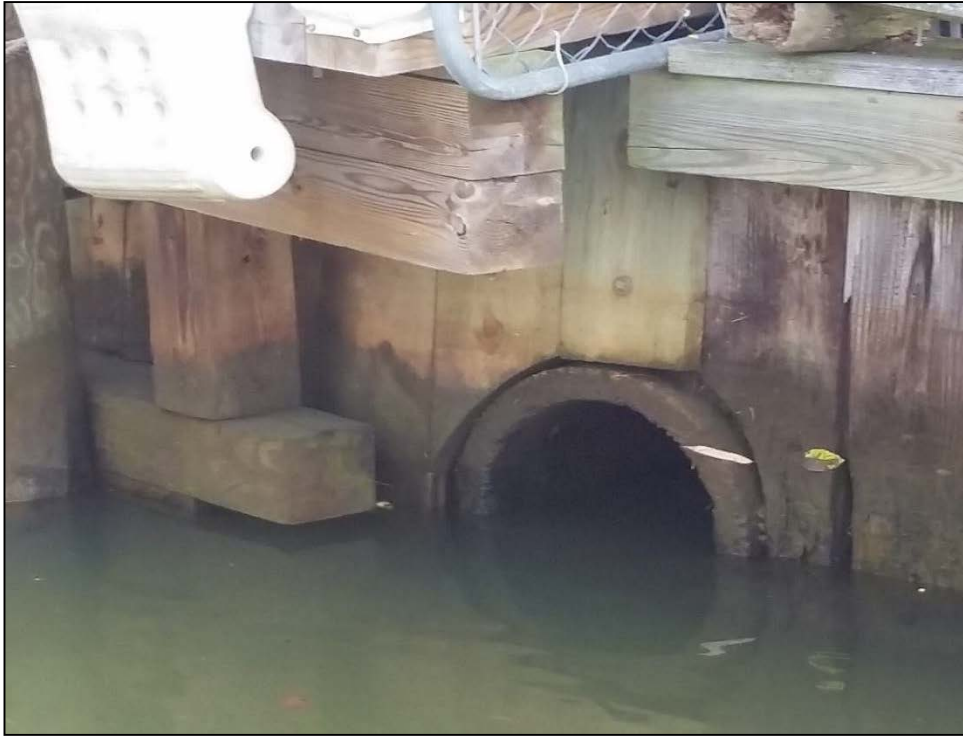
Stormwater outfall discharge to the canal.

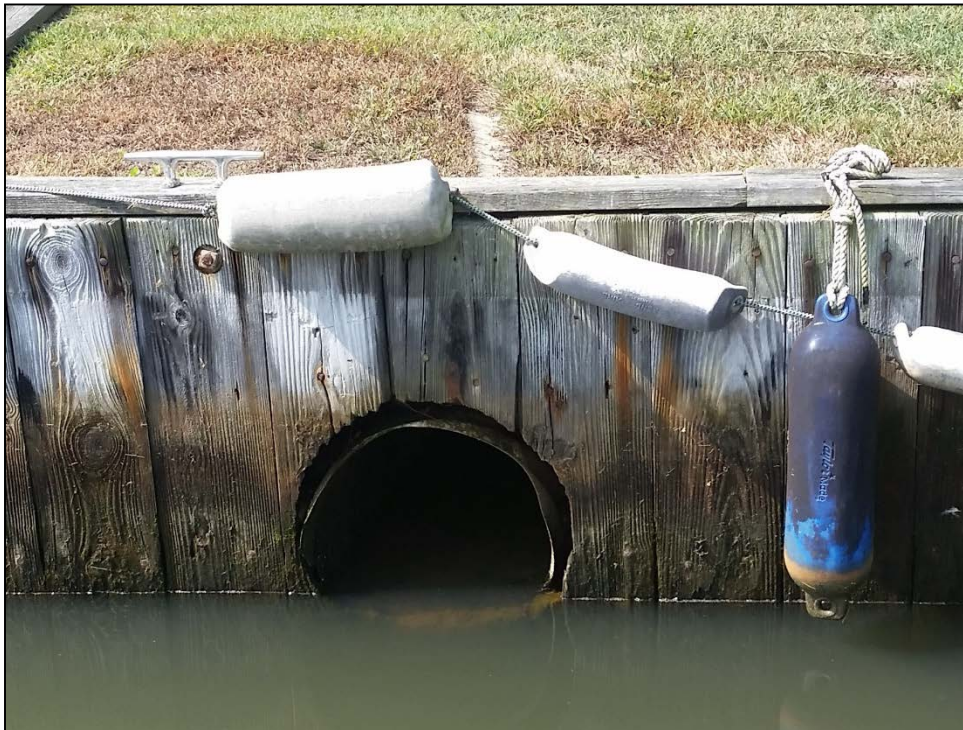
Stormwater outfall discharge to the canal.

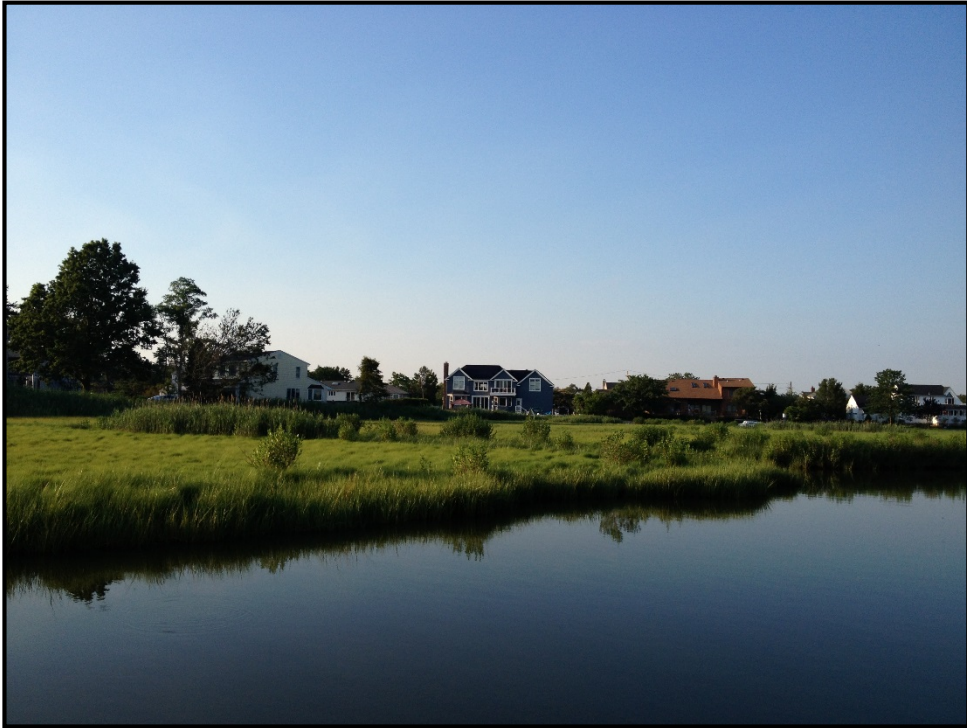
Some wetlands along portions of canal not enclosed by embankment are in better ecological condition.

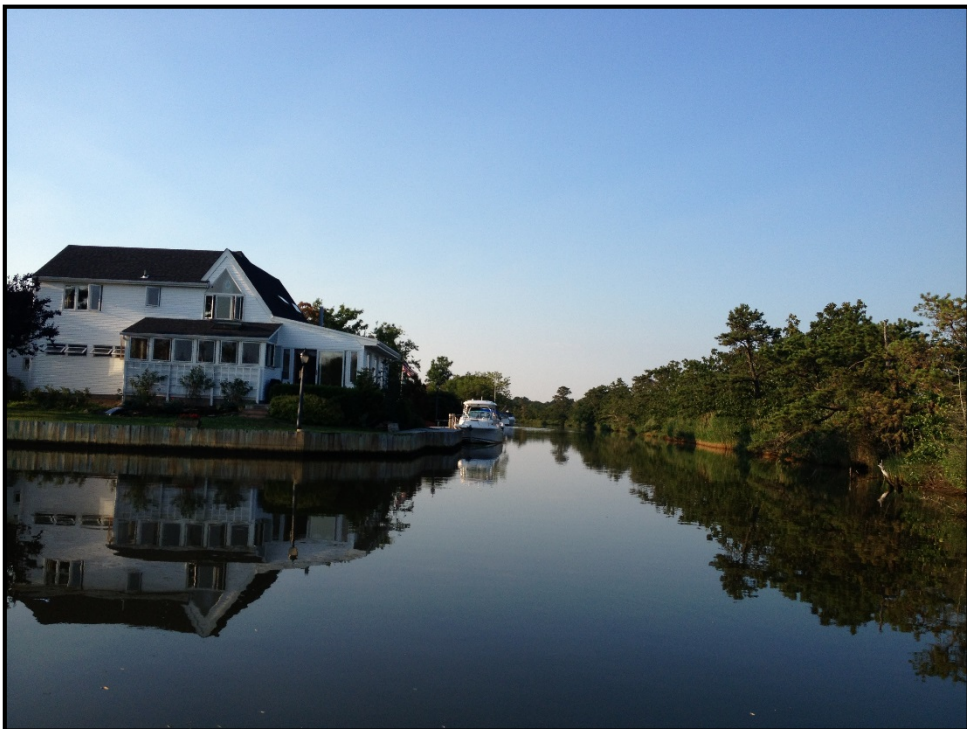
Many homes in close proximity to canal edge.

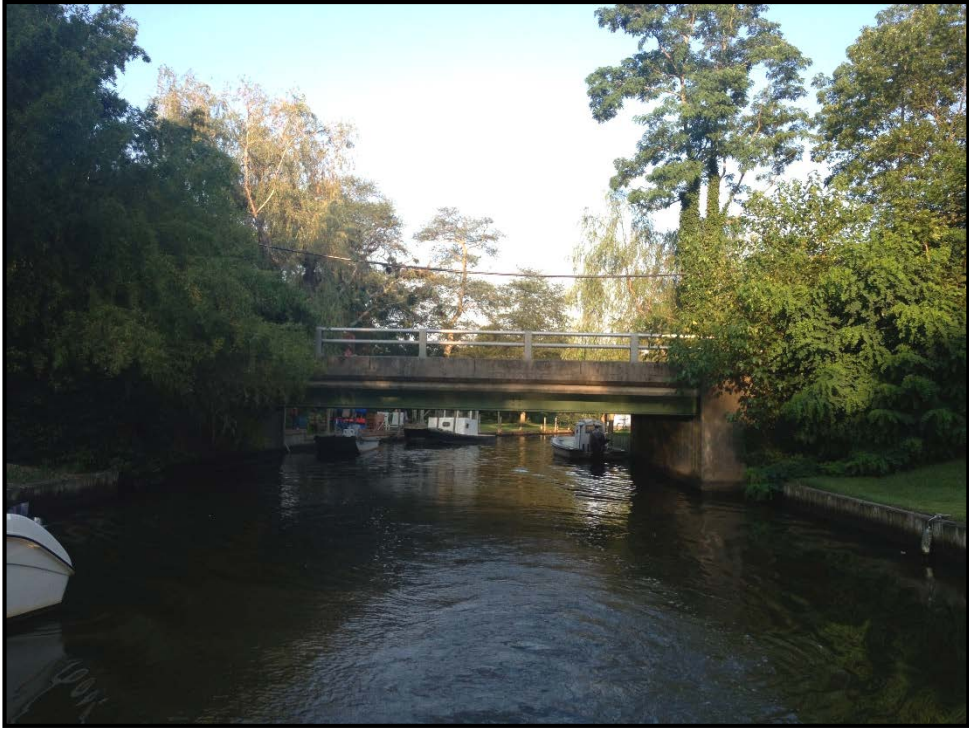
Low bridges restrict access by large boats for much of the canal.

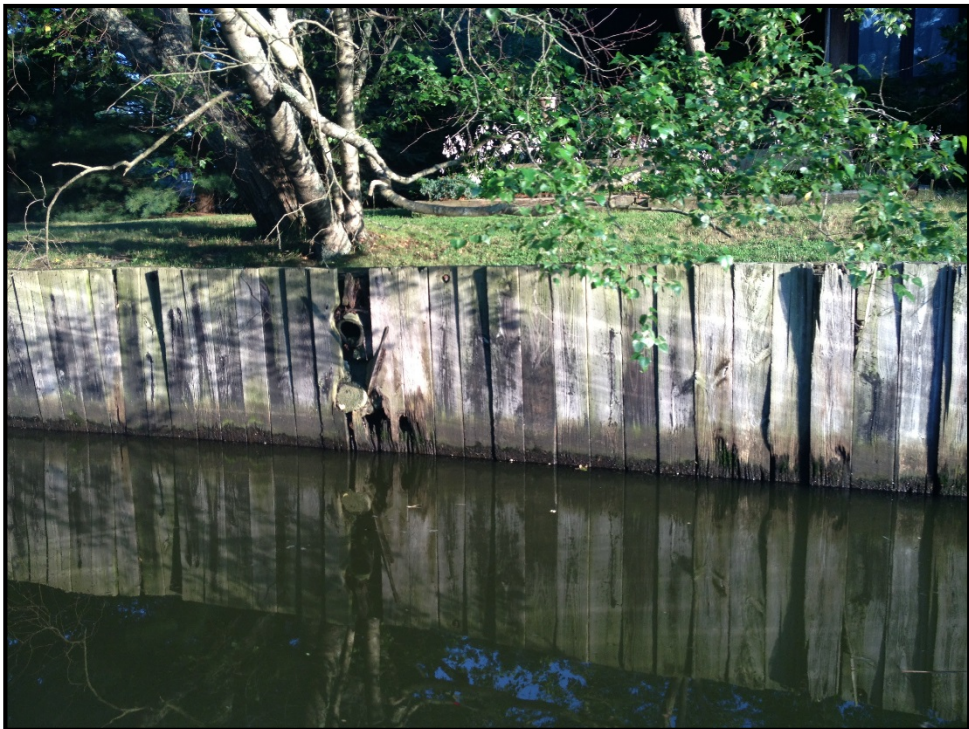
Portions of bulkheads along the canal shoreline on private property are in severe disrepair.

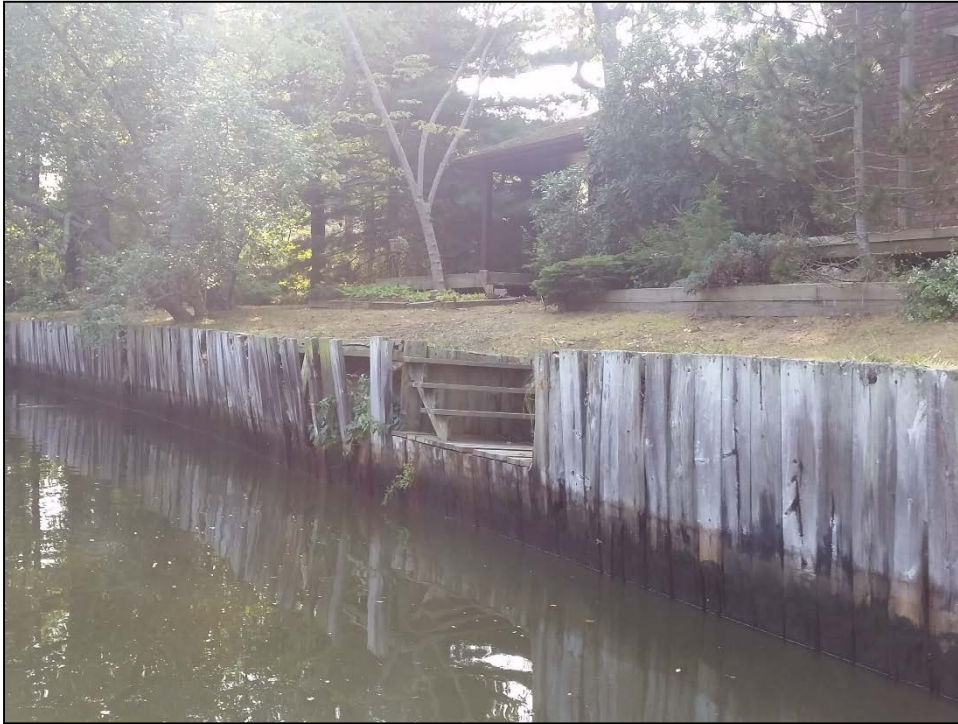
Portions of bulkheads along the canal shoreline on private property are in severe disrepair.

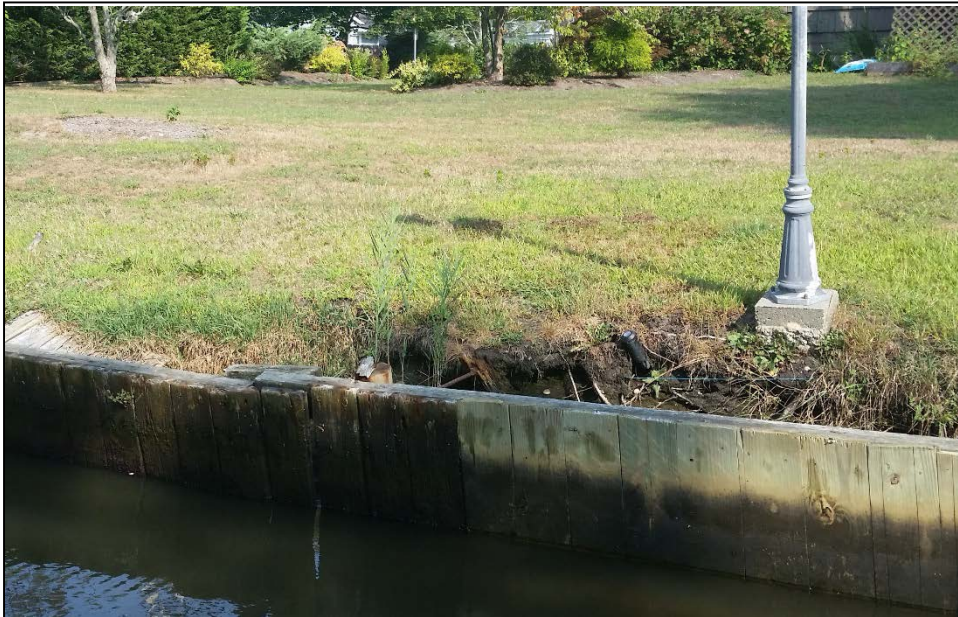
Portions of bulkheads along the canal shoreline on private property are in severe disrepair.

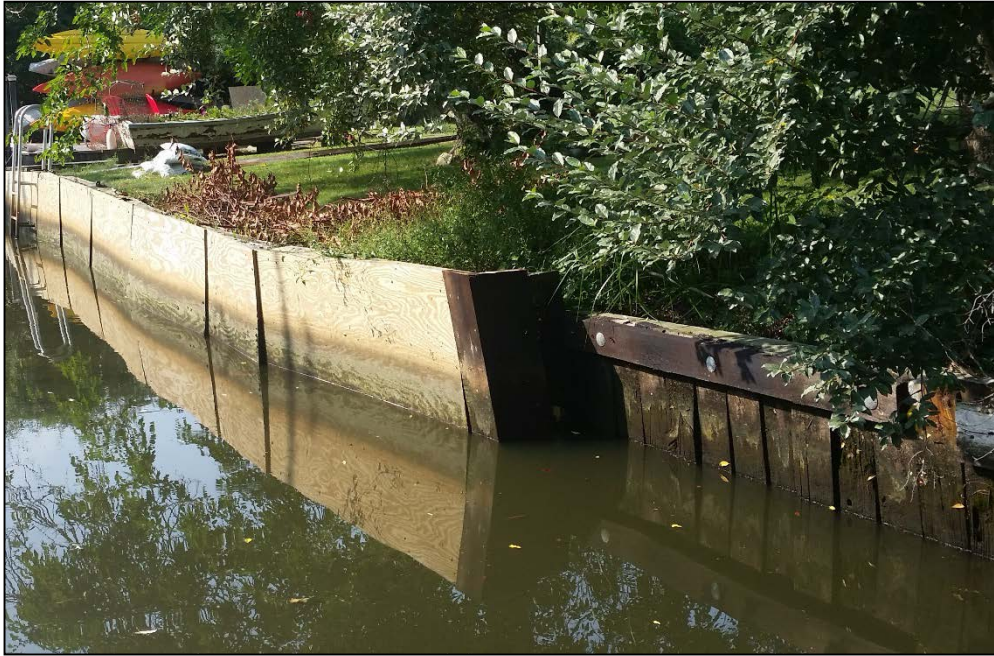
Many bulkheads appear to be vulnerable to failure.

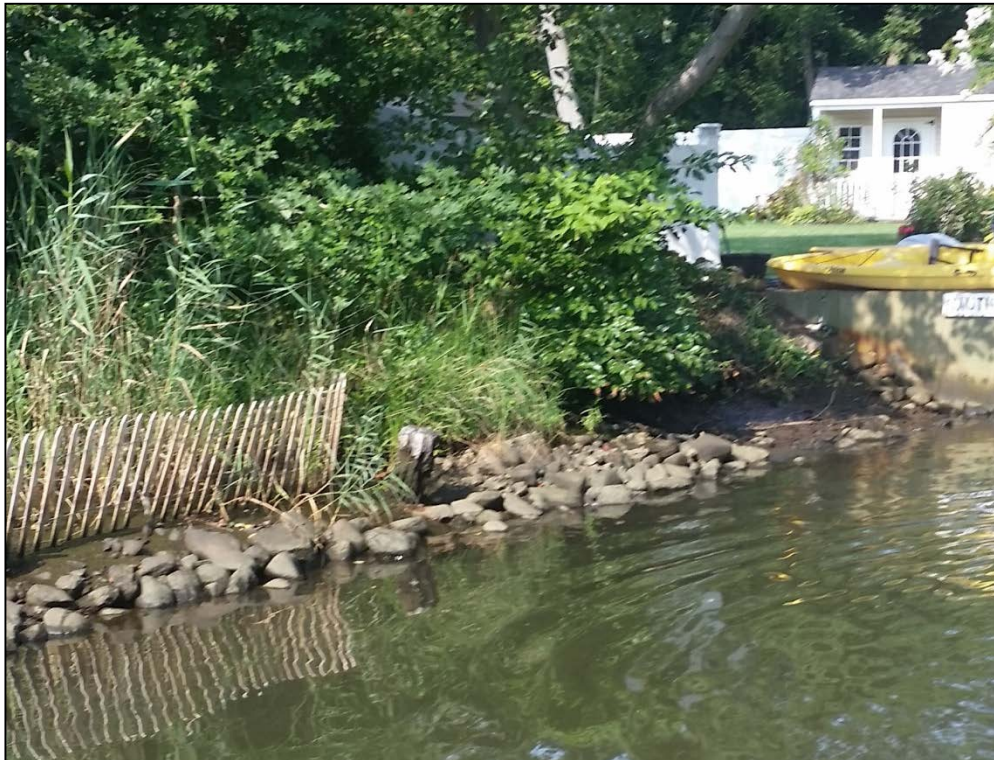
Portions of shoreline on residential properties have rock and debris reinforcement.

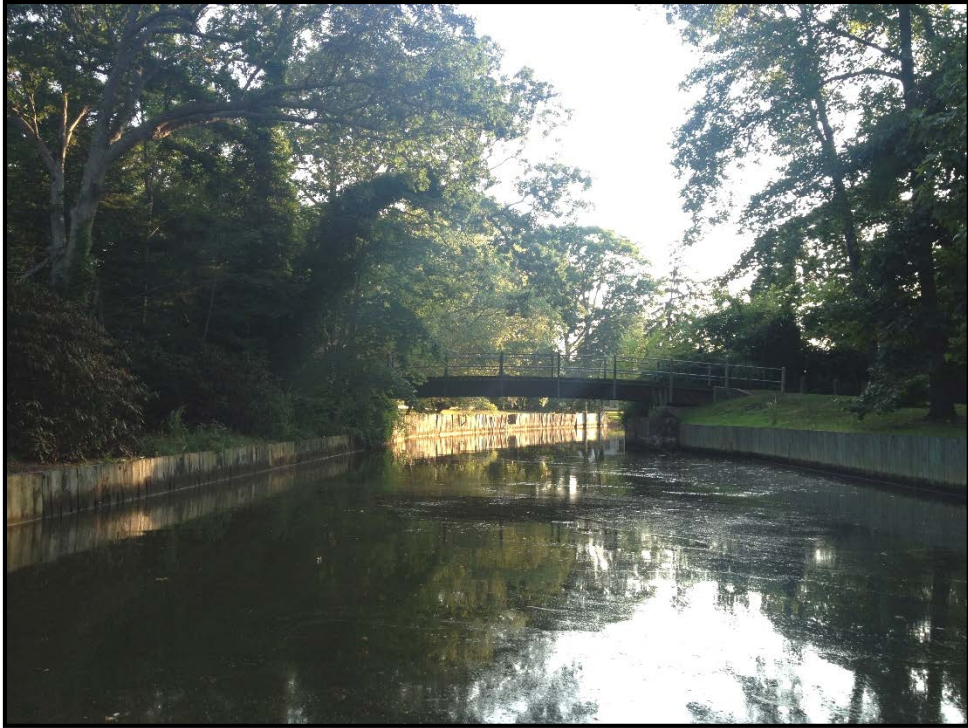
Area of accumulated floating debris indicates zone of poorly circulated water in interior segments of the canal.
