## **Section 2. Review of Existing Data (Task 2)**

### **2.0 Grand Canal Environmental Assessment Report- 2005**

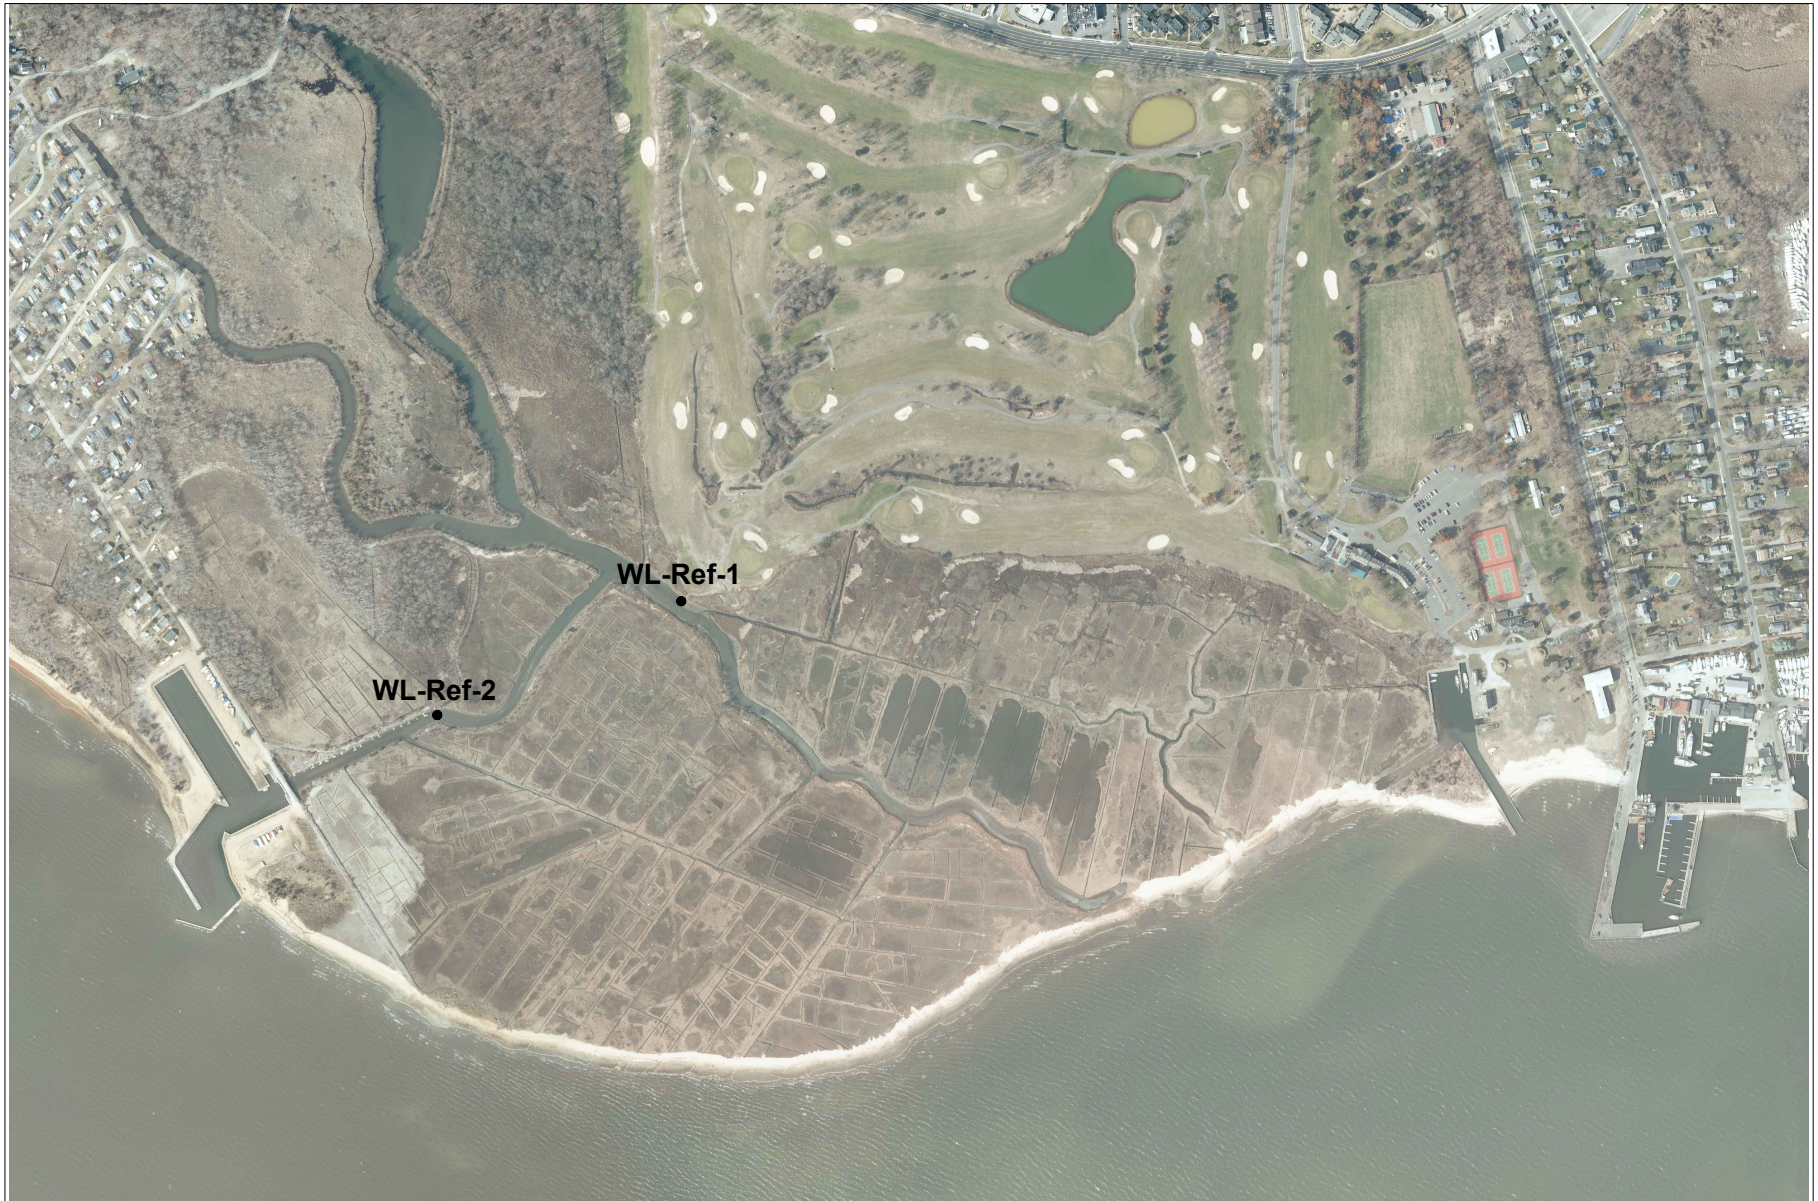
NOT TO SCALE

CA identified a reference area similar to the Grand Canal study area but where the water quality is considered good, wetlands are considered healthy, and water flow is considered optimal for maintenance of water/wetlands quality. The reference area selected by CA was Indian Creek which is located on the border of West Sayville and Oakdale approximately two miles east of the Grand Canal (Map 2).
