## **Section 3. Data Collection and Analysis (Task 3)**

### **3.0 Physical Characteristics of the Water Body (Subtask 3a)**

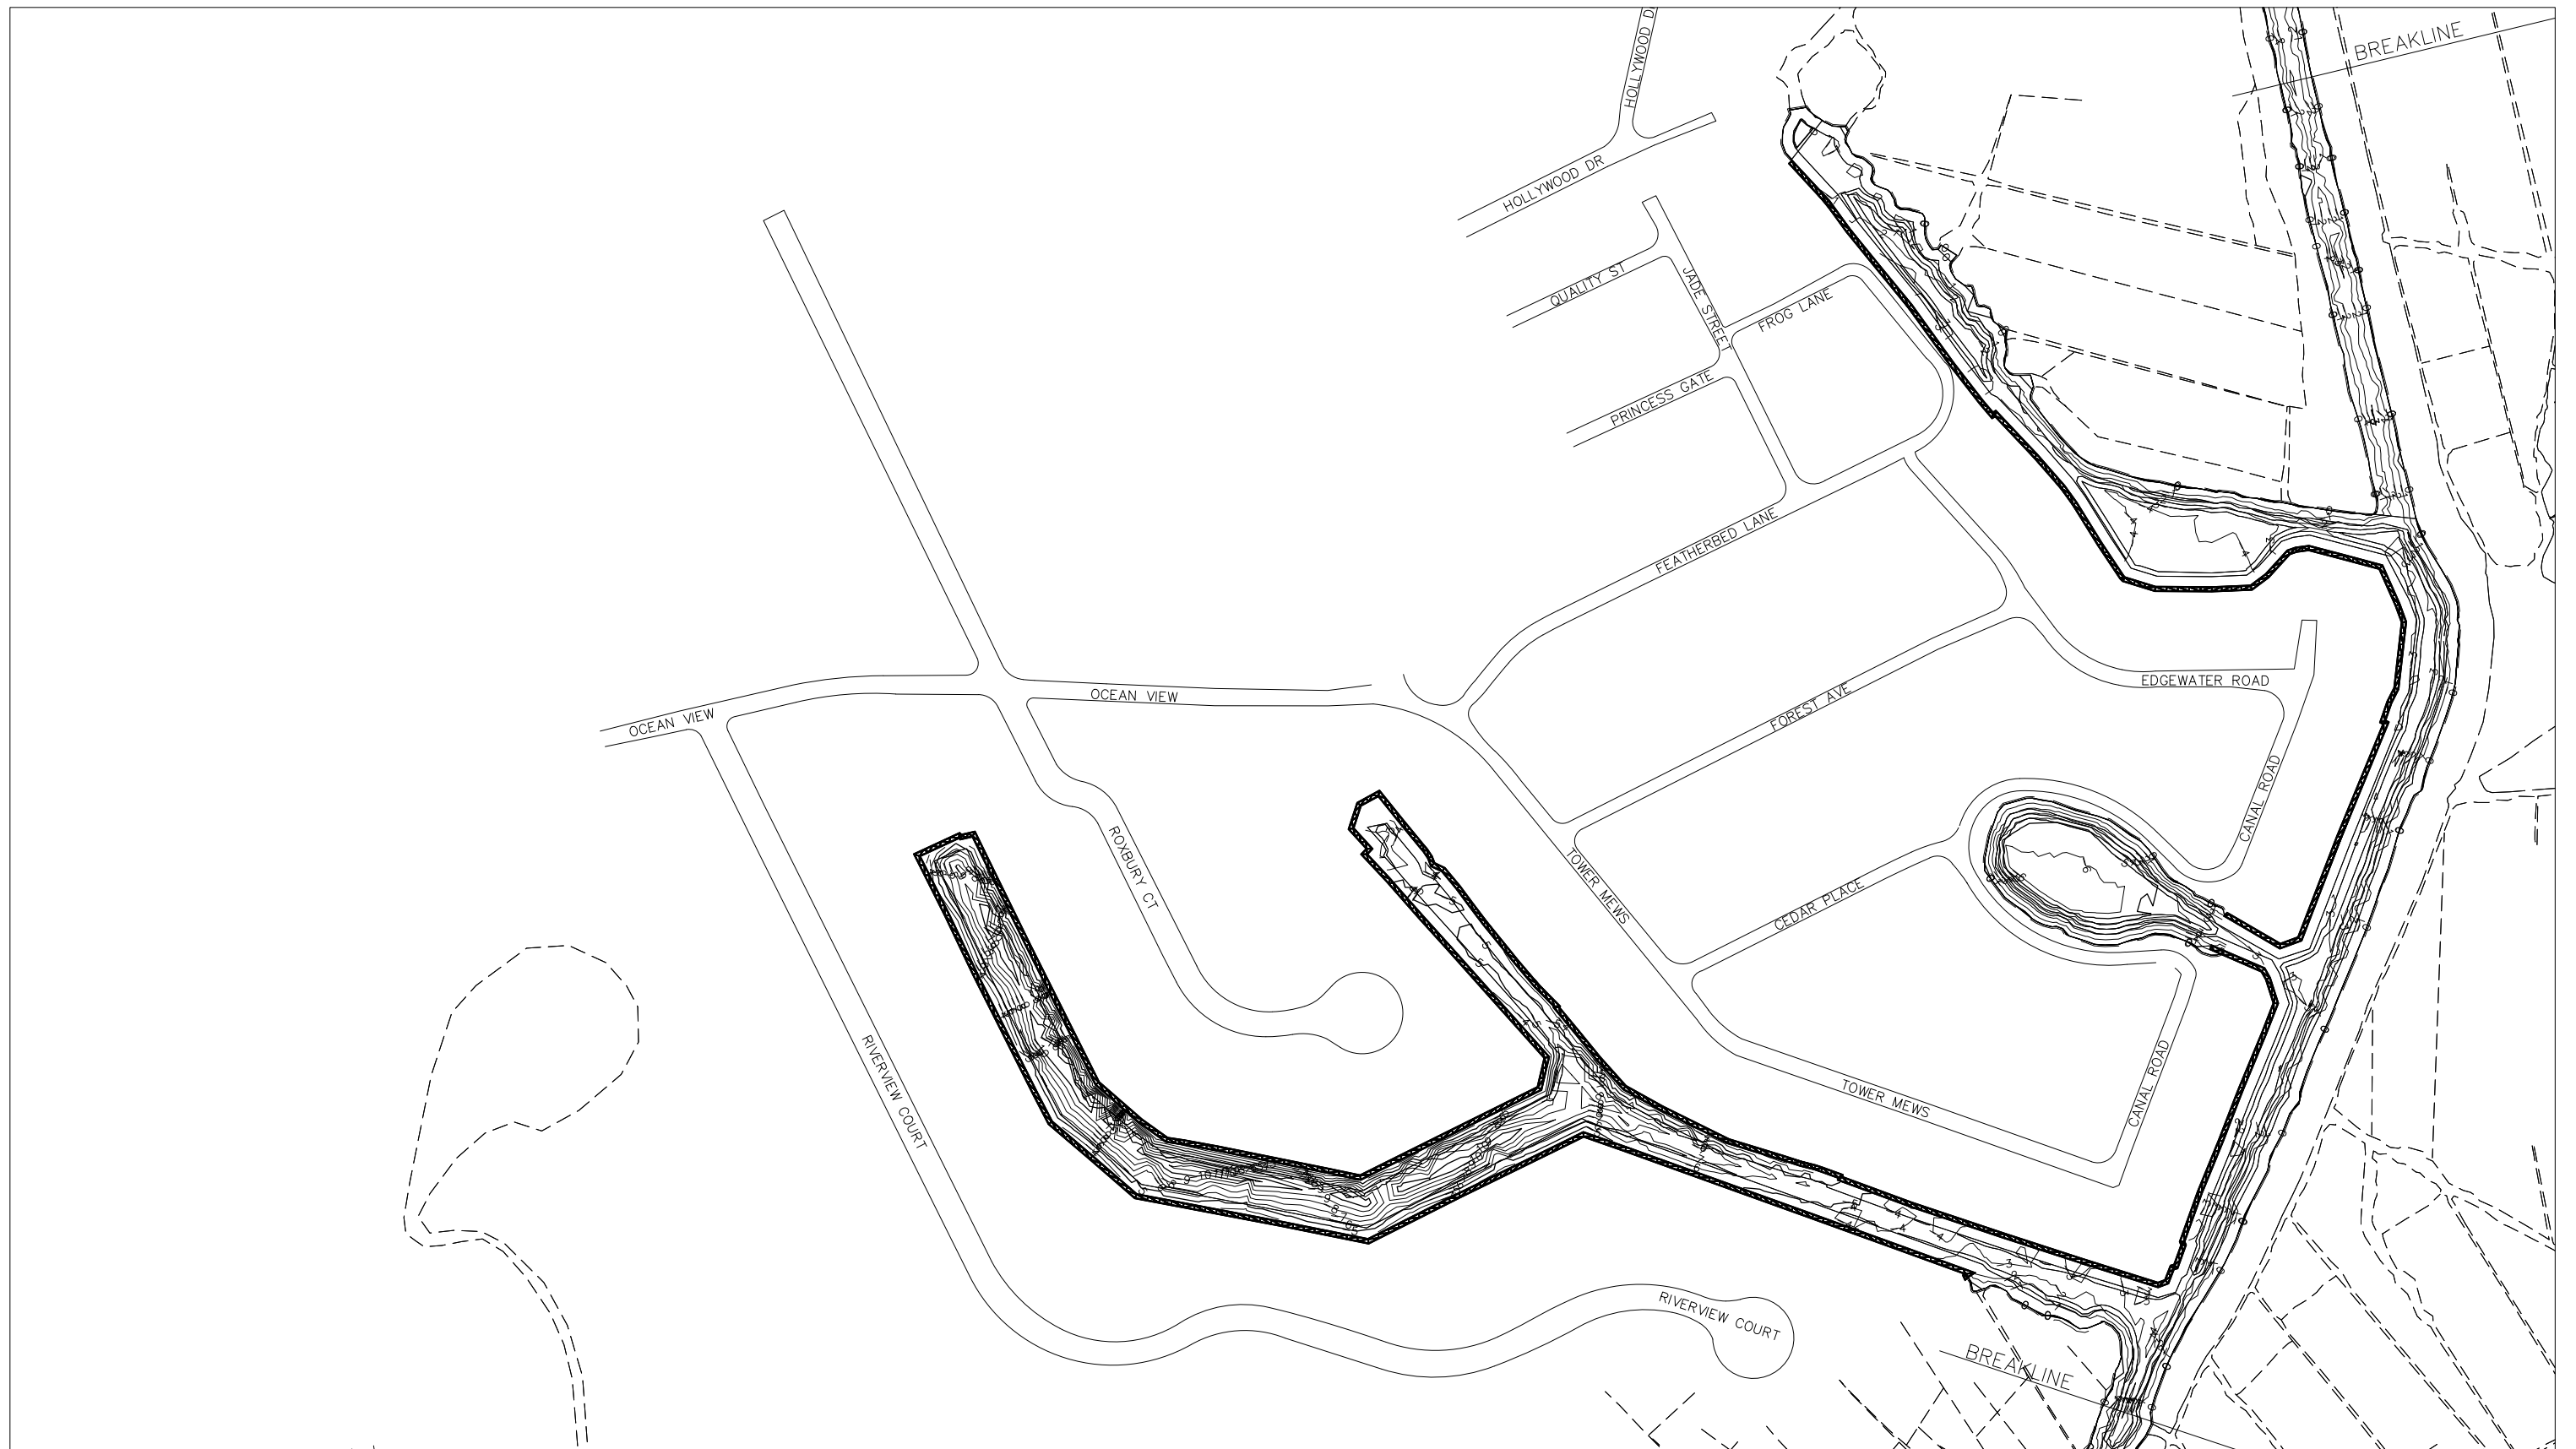
MAP 3

A total of 845 bathymetric data points were collected during the bathymetric survey event. Bathymetric maps were created from these data, as shown in Map 3. Mapping was based on mean low water (MLW) as dictated by NGVD29 and NAD83 State Plan Coordinates, New York Long Island Zone.

*Bathymetry*

The main section of the Grand Canal was found to vary in width from approximately 75-feet at its widest point (just south of the Shore Drive Bridge) to approximately 30-feet at its narrowest point (just east of the Idle Hour Boulevard Bridge). The main channel of the canal varies in depth from the deepest point of approximately five feet below mean low water (MLW) near the southern entrance to approximately two feet below MLW at its shallowest along the northern transect of the canal (Map 3). The entrance of the canal at the Snapper Inn is actually narrower than the main section of the canal, with a width of about 25 feet.

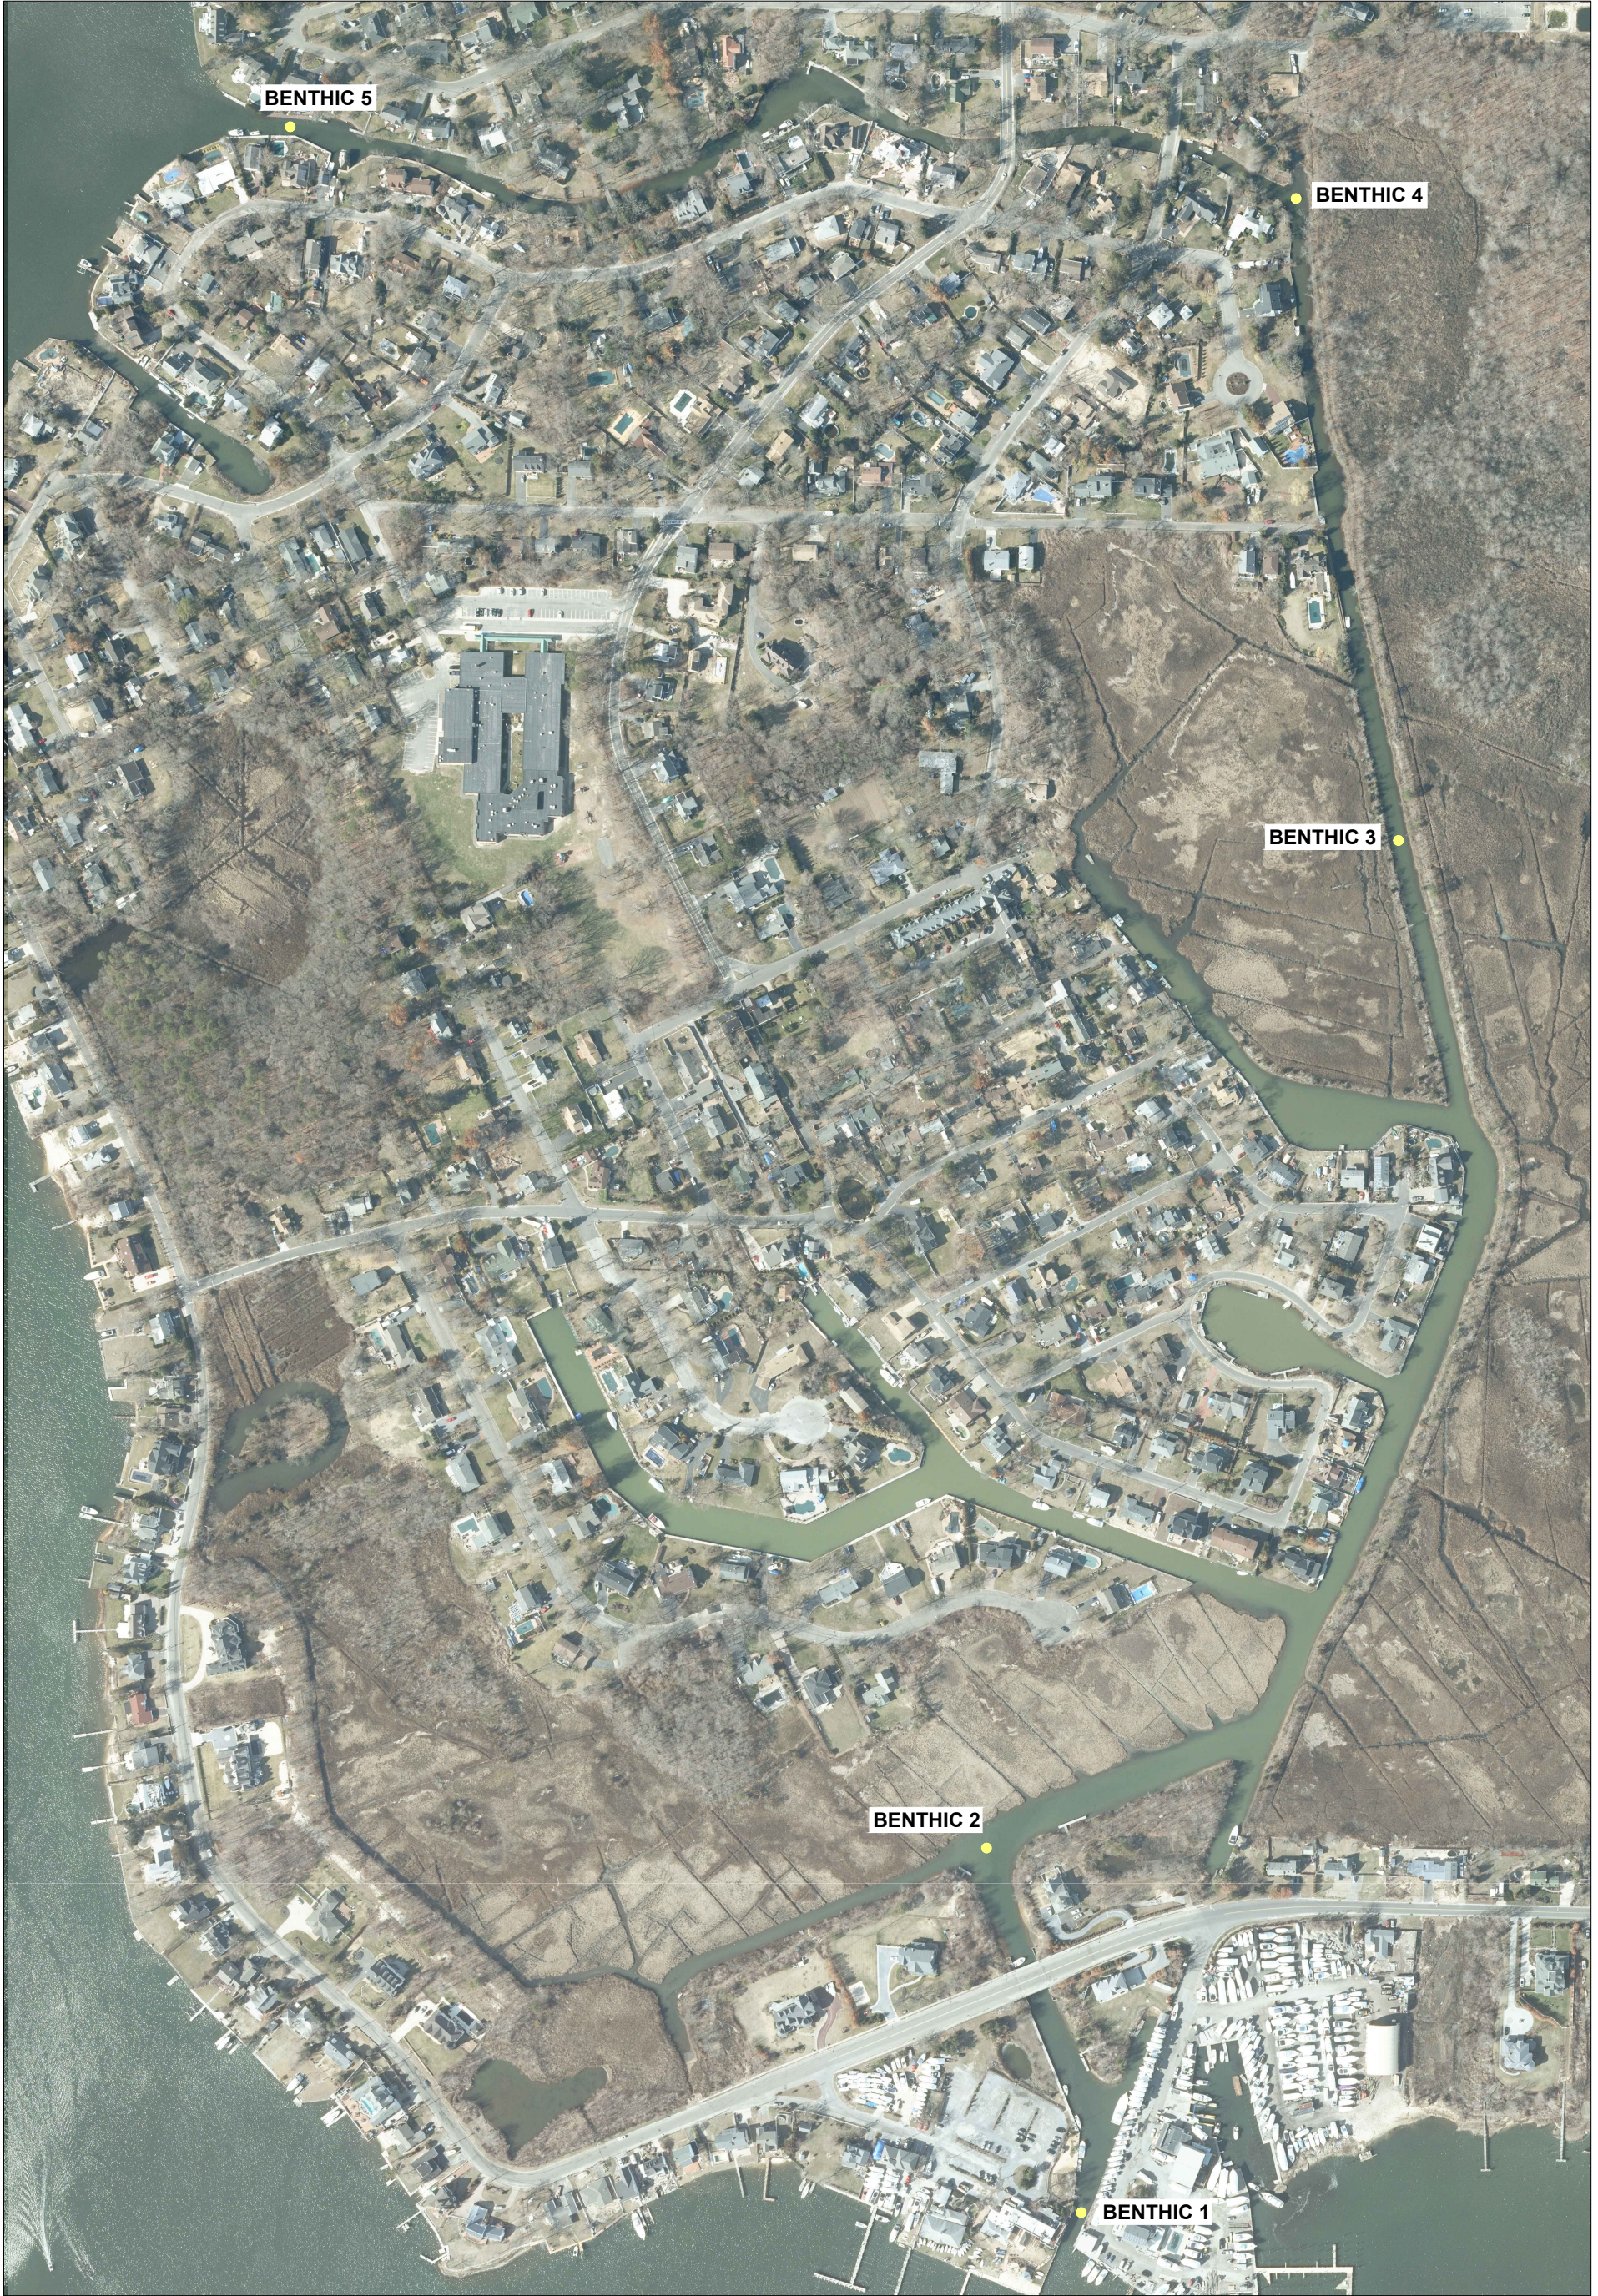
MAP 4

*Benthic Community*  
*Sampling Locations*

characteristics. GPS coordinates for each sample location were recorded and sample locations are provided in Map 4. The benthic sampling protocols (e.g., number of samples, location of samples, sampling procedure) were developed in accordance with the Description of Services for the project.

Spring benthic samples were collected on June 4, 2015 from a total of five sites with two replicates at each site (totaling ten samples) (Map 4). A total of 222 benthic organisms were collected from all ten samples. A total of ten species were identified during the spring event. *Ampelisca spp.* was the most abundant species with 127 benthic organisms found in six of the ten samples collected. *Myodocopido spp.* was the next most abundant species with 31 organisms found in two of the ten samples. Replicate 1a had the highest species richness with a total eight different organisms identified. Table 3 depicts the spring benthic organism abundance by species and sample.

Fall benthic samples were collected October 7, 2015 from a total of five sites with two replicates at each site (totaling ten samples) (Map 4). A total of 98 benthic organisms were collected from all ten samples; this is less than half of the amount of organisms collected during the spring event. A total of 11 species were identified during the fall event; this is one more species than was identified during the spring event. *Ampelisca spp.* was the most abundant species with 79 organisms found in five of the ten samples collected. *Luimbrineris tenuis* was the next most abundant species with only six organisms in two of the ten samples. Replicate 2a had the highest species richness with a total four different species identified. Table 5 depicts the fall benthic organism abundance by species and sample.
